## **Laborer Dies when Crushed Between Forklift Cage and Mast**

### **SUMMARY**

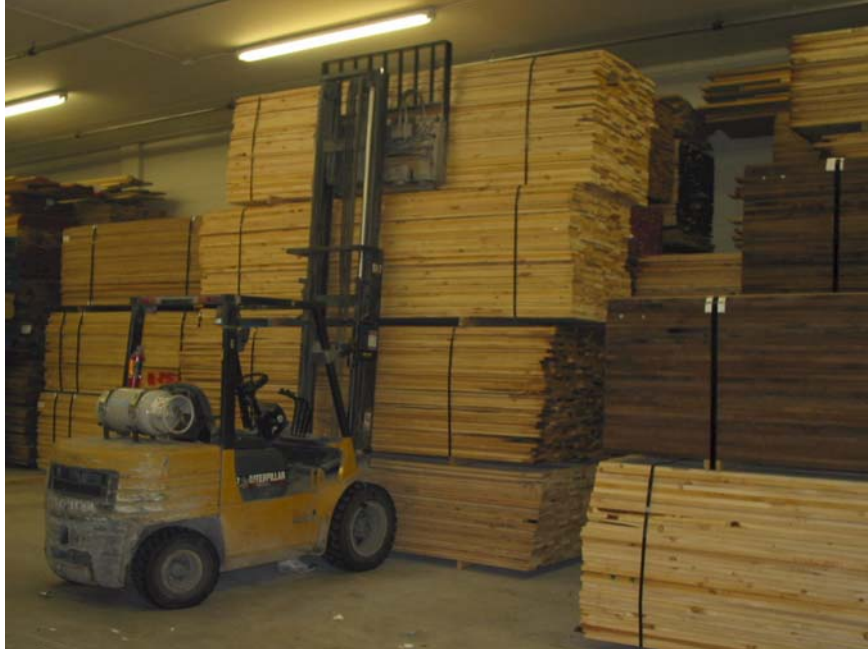
would be placed, was missing. (Figure 1.) The victim apparently climbed to the top of the bundle on the forklift to the area where the spacer should have been, and slipped, falling into the forklift controls. This caused the mast to tilt backwards and pin him. He was alone at the time of the incident and was found pinned between the forklift cage and the mast by the semi-truck driver. The semi-truck driver summoned other employees in the

Figure 1. The forklift stacking the fourth bundle of lumber.

Discussion: If there is a problem with unloading or stacking the load, the load should be lowered and a safe strategy to get the job completed must be identified. In this case, if the load had been lowered, the victim would not have been able to reach the top of the third stack of bundled lumber. Employers should ensure that equipment is available for gaining safe access to elevated areas. Appropriate ladders, mobile scaffolds and/or lifts used in accordance with OSHA safety standards can be used for this purpose.

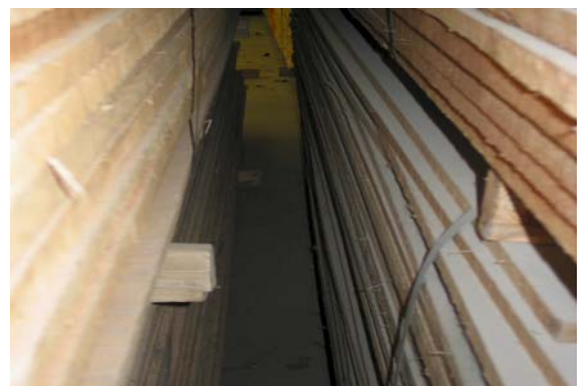
The company purchased lumber that was delivered on a semi-truck to the warehouse where the incident occurred. The victim's job at the warehouse was to use the Caterpillar forklift and transport the bundled lumber from the semi-truck and stack it against the wall in the warehouse. Each bundle was placed on a 2" x 4" x 4' board that was stacked edgewise on the 2" edge to be used as a spacer between the bundles of lumber when they were stacked against the wall. (Figure 2) One of the 2" x 4" x 4' spacers was placed on the left end of the, while another was placed on the right end of the bundle of lumber. When the bundled lumber was taken from the semi-truck, the load was lowered to the ground and the two loose 2" x 4" x 4' spacers were placed on each end at the

Figure 2. The spacers are stacked edge-wise.

top of the bundled lumber. Following this procedure, the load was transported via forklift to the wall where the bundled lumber was stacked. The load was raised and the bundled lumber was placed in its final position against the wall. This method ensured the 2" x 4" x 4' spacers were in place for the next bundle to be stacked on top of them.

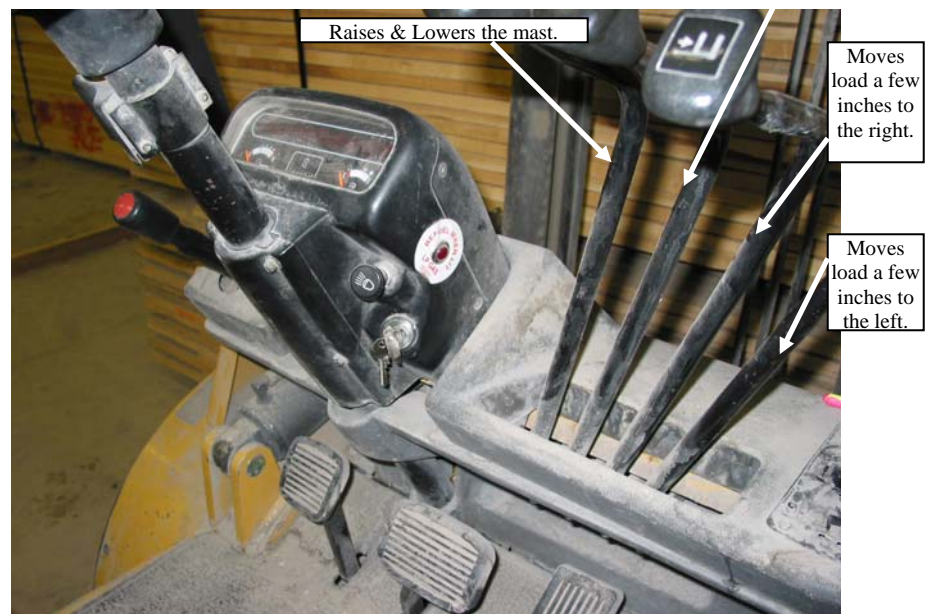
Tilts the mast away or toward the forklift.

The forklift had four levers to operate the direction of the load. Starting from the left side of the four levers, the first lever on the left raised and lowered the mast. The second lever tilted the mast either away from or towards the forklift. The third lever allowed the operator to move the load a few inches to the right and the fourth lever allowed the operator to move the load a few inches to the left. (Figure 3) It is surmised that when the victim fell between the mast and the front of the cage area, he initiated the second lever which caused the mast to tilt back towards the cage, pinning him between the mast and the cage.

Figure 3. Forklift controls.

Discussion: OSHA standards for general industry 1910.178 state that when the operator of a forklift is dismounted and within 25 feet of the forklift still in his view, the load engaging means shall be fully lowered, controls neutralized and the brakes set to prevent movement. The Caterpillar Maintenance and Operator's Manual states the following when leaving the forklift or parking it:

- Set the parking brake.
- Put the direction lever in neutral.
- Place the lock knob in the lock position.
- Lower the forks fully to the floor. Tilt the mast forward until the forks are flat.
- Turn off the key.

Hands, feet and all body parts should be kept away from the mast, reach mechanism and other pinch points. Do not climb on any part of the forklift.
